The Ultimate Safety Guide for Solar PV Connectors

An In-Depth Primer with Best Practices for Solar Professionals and Asset Owners

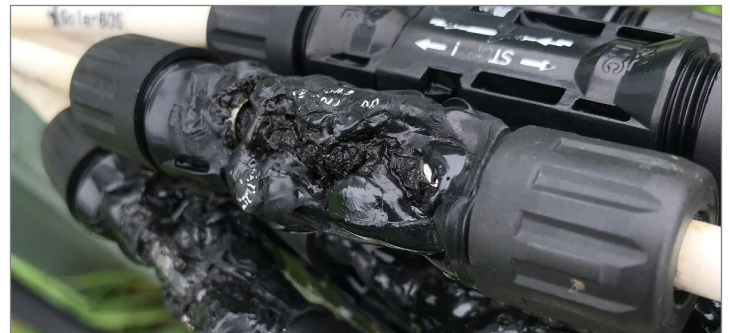
Burnt and melted connectors at an operating project.

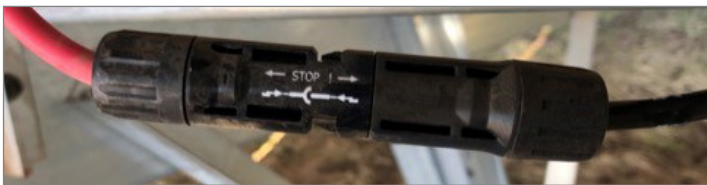
A mismatched MC4 and MC4-compatible connector in the field at a site with extensive connector failures.

Do not allow cross-mated connectors unless they are tested and certified together as a single component. Obtain new connectors from module manufacturers if necessary.

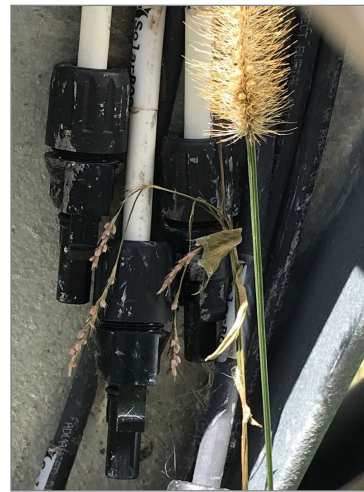
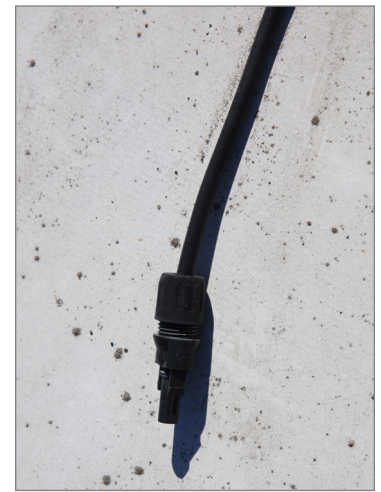
Connectors that are left unplugged and uncapped during construction are often exposed to moisture and foreign particulates, such as dirt or other organic matter. Without connector caps, the metal pins of the connectors will be exposed to moisture and begin to corrode.

Then, once the connector is closed, the corrosion continues to propagate, increasing connector resistance until the connection eventually fails. **These connectors can become time bombs waiting to ignite to the field.**

The connectors above are examples of potential time bombs: they were left unplugged without end caps at a utility-scale plant (left) and a commercial rooftop system (right).

Use manufacturer-provided crimping tools. String modules immediately to prevent environmental exposure and use end caps when necessary. Document the status and location of all field-made connectors at the time of installation.

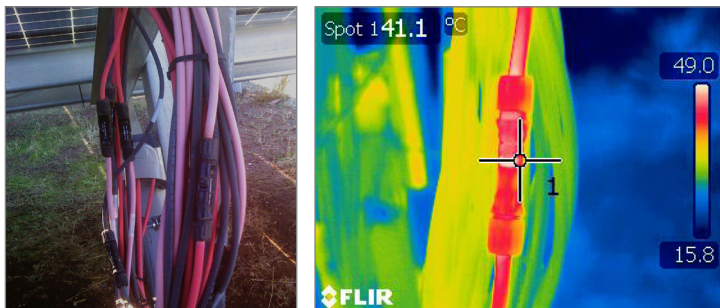
The images above show differential temperature failures. One of the connectors in the bundle (left) has an operating temperature that is 15°C higher than the others, as indicated by the thermal image (right).

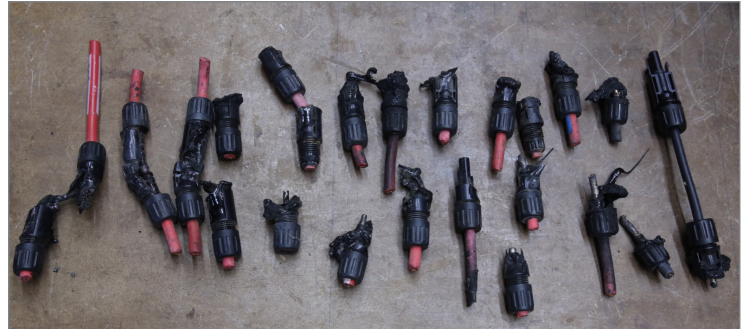
The sample of failed connectors above melted due to high temperature operation in the field. PVEL removed the devices from the field for testing and root cause failure analysis.

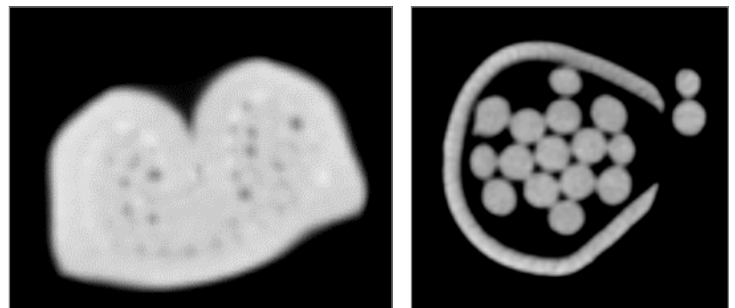
The above XCT cross-section images show the difference between a correct (left) and poor (right) connector crimp found by PVEL in an active PV installation.

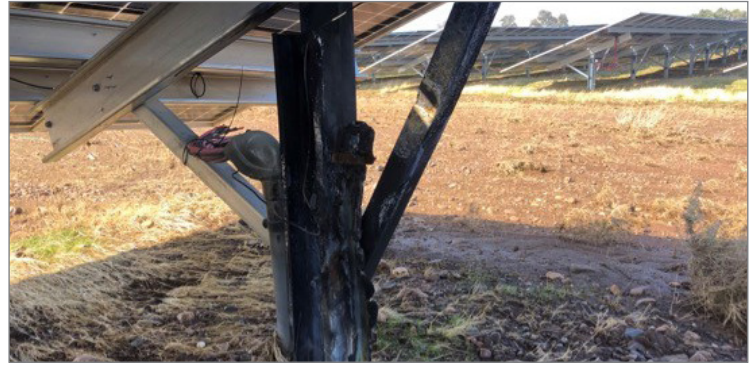
A single overheated connector caused this catastrophic failure. Per PVEL's testing, installation error is likely the root cause.

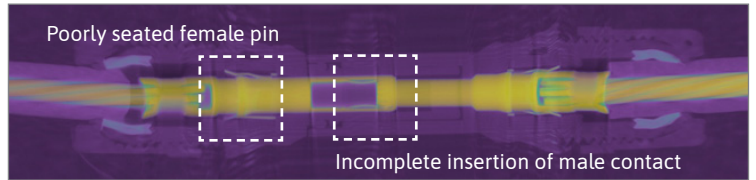
- Critical connector installation errors were extensive, including under- and overtightened nuts, poor placement, improper crimping, and improperly seated contacts.
- 40% of the connectors evaluated with XCT had installation issues, and 20% had incomplete insertion of the contact, which suggests issues are widespread throughout the site.
- Persistent inverter nuisance tripping based on insulation resistance faults could be due to the widespread poor sealing of connectors due to under-torqued back nuts.

These XCT images show two poorly installed connectors. The top image reveals incomplete insertion and the left image zooms in on a channel for water ingress due to an undertorqued nut.

PVEL recommended further inspection and/or total replacement of all field-made connectors in the project due to significant installation errors.
